**Flood Control Project Maintenance  
Levee Inspections**

## Maintenance Issue Types Only, Levee Inspection Report By Mile - Spring 2015

### Lake County Watershed Protection District

Waterway	Bank	Unit Miles	Inspection Start/End	Inspector
Unit No. 01 Middle Creek	Left	3.35	04/09/2015 04/09/2015	Bob Duffey

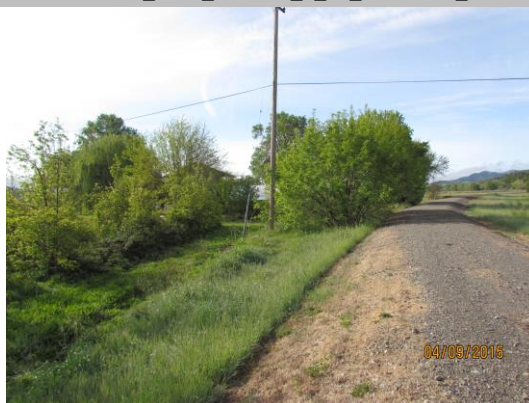
Photo 1 of 1 : SP\_2015\_NA0009\_3\_11\_20150420\_00094.jpg

Remove the trees from the landside slope.

LM Start	0.26	Rating **	M	Issue No.	11
LM End	0.26	Issue Type +	Ma	Location *	LS
Category	Earthen Levee			GPS Latitude/Longitude	
				Start	End
Item	Trim / Thin Trees			39.186777 °	39.186777 °
				-122.908102 °	-122.908102 °
DWR ID	DWR_NA0009_01_s _ 2013_11				
Action/Comments					
Trim and thin trees to allow visibility of the ground and room to flood fight.					
Inspector Comments: Remove the trees from the landside slope.

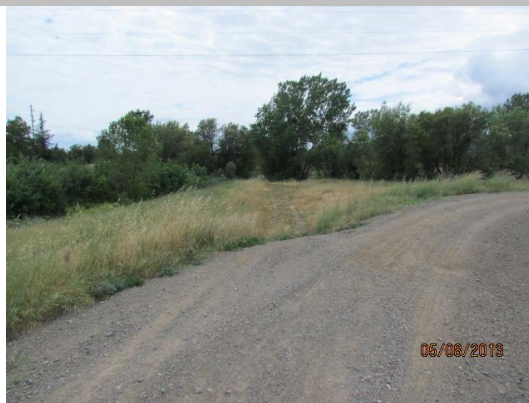
Photo 1 of 1 : SP\_2015\_NA0009\_3\_13\_20150310\_00007.jpg

View of the vehicle erosion along the waterside slope.

LM Start	2.29	Rating **	M	Issue No.	13
LM End	2.29	Issue Type +	Ma	Location *	WS
Category	Earthen Levee			GPS Latitude/Longitude	
				Start	End
Item	Slope Stability			39.160285 °	39.160285 °
				-122.913481 °	-122.913481 °
DWR ID	DWR_NA0009_01_s _ 2013_13				
Action/Comments					
Repair the levee slope damaged by vehicle traffic and prevent access where possible.

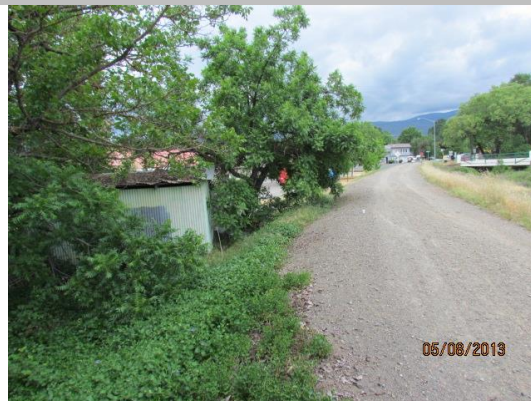
Photo 1 of 1 : SP\_2015\_NA0009\_3\_15\_20150310\_00009.jpg

Trim the trees up 5 feet to allow visibility.

LM Start	2.38	Rating **	M	Issue No.	15
LM End	2.41	Issue Type +	Ma	Location *	LS
Category	Earthen Levee			GPS Latitude/Longitude	
				Start	End
Item	Trim / Thin Trees			39.161381 °	39.161708 °
				-122.912551 °	-122.912168 °
DWR ID	DWR_NA0009_01_s _ 2013_15				
Action/Comments					
Trim trees to at least five feet above ground level.

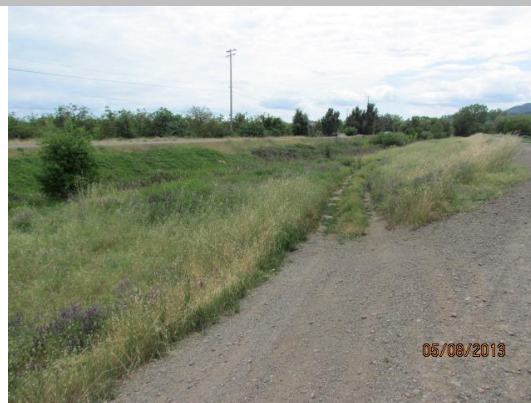
Photo 1 of 1 : SP\_2015\_NA0009\_3\_16\_20150310\_00010.jpg

View of the vehicle erosion along the waterside slope.

LM Start	2.40	Rating **	M	Issue No.	16
LM End	2.40	Issue Type +	Ma	Location *	WS
Category	Earthen Levee			GPS Latitude/Longitude	
				Start	End
Item	Slope Stability			39.161601 °	39.161601 °
				-122.912303 °	-122.912303 °
DWR ID	DWR_NA0009_01_s _ 2013_16				
Action/Comments					
Repair the levee slope damaged by vehicle traffic and prevent access where possible.

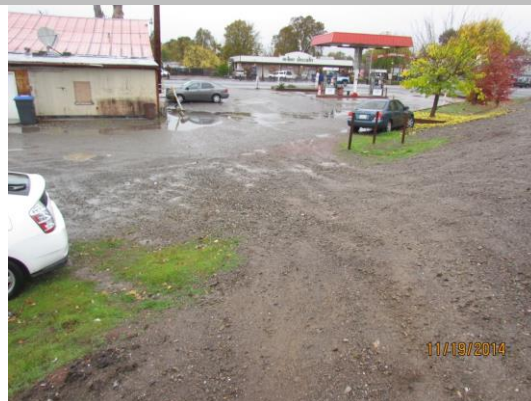
Photo 1 of 1 : SP\_2015\_NA0009\_3\_17\_20150310\_00011.jpg

View of the erosion along the landside slope.

LM Start	2.42	Rating **	M	Issue No.	17
LM End	2.42	Issue Type +	Ma	Location *	LS
Category	Earthen Levee			GPS Latitude/Longitude	
				Start	End
Item	Slope Stability			39.161802 °	39.161802 °
				-122.912020 °	-122.912020 °
DWR ID	DWR_NA0009_01_s _ 2013_17				
Action/Comments					
Repair the levee slope damaged by vehicle traffic and prevent access where possible.

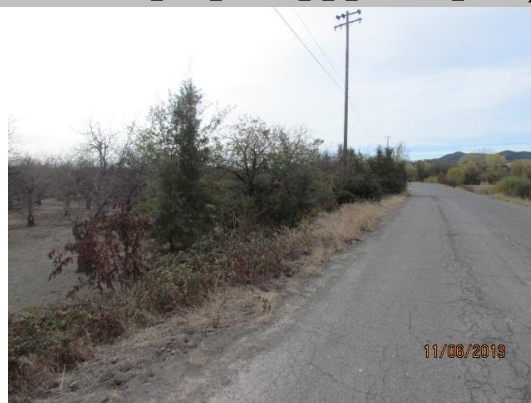
Photo 1 of 1 : SP\_2015\_NA0009\_3\_3\_20150310\_00001.jpg

View of the vegetation along the landside slope.

LM Start	2.48	Rating **	M	Issue No.	3
LM End	2.54	Issue Type +	Ma	Location *	LS
Category	Earthen Levee			GPS Latitude/Longitude	
				Start	End
Item	Vegetation			39.161615 °	39.160795 °
				-122.911733 °	-122.912442 °
DWR ID	DWR_NA0009_01_s _ 2012_3				
Action/Comments					
Remove the wild growth other than native grasses from the levee slopes.

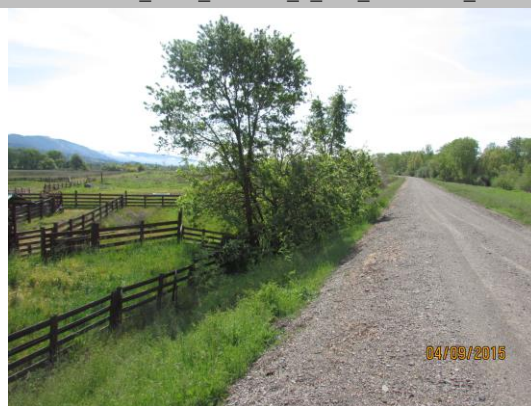
Photo 1 of 1 : SP\_2015\_NA0009\_3\_534\_20150420\_00095.jpg

Remove the trees from the landside toe.

LM Start	3.24	Rating **	M	Issue No.	534
LM End	3.24	Issue Type +	Ma	Location *	LS
Category	Earthen Levee			GPS Latitude/Longitude	
				Start	End
Item	Trim / Thin Trees			39.151148 °	39.151148 °
				-122.913652 °	-122.913652 °
DWR ID	DWR_NA0009_01_s _ 2015_534				
Action/Comments					
Thin trees to allow visibility of the ground and room to flood fight.

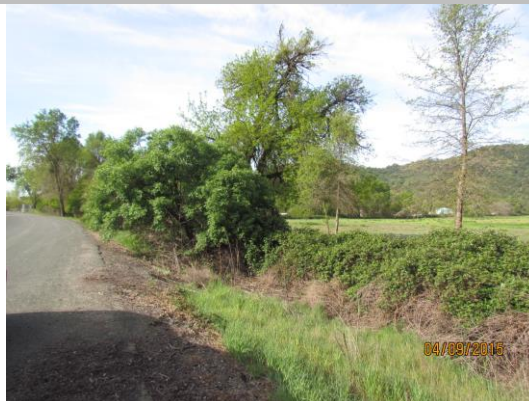
Photo 1 of 1 : SP\_2015\_NA0009\_4\_19\_20150420\_00113.jpg

LM Start	0.08	Rating **	M	Issue No.	19
LM End	0.08	Issue Type +	Ma	Location *	LS
Category	Earthen Levee			GPS Latitude/Longitude	
				Start	End
Item	Vegetation			39.188772 °	39.188772 °
				-122.908465 °	-122.908465 °
DWR ID	DWR_NA0009_02_s _ 2014_19				
Action/Comments					
Elderberries are blocking visibility and flood fight capability.

View of the elderberries along the landside toe.

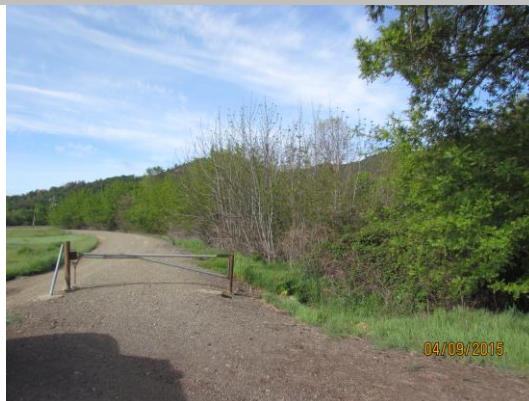
Photo 1 of 1 : SP\_2015\_NA0009\_4\_9\_20150420\_00114.jpg

Trim the trees up 5 feet to allow visibility.

LM Start	0.24	Rating **	M	Issue No.	9
LM End	0.29	Issue Type +	Ma	Location *	LS
Category	Earthen Levee			GPS Latitude/Longitude	
				Start	End
Item	Trim / Thin Trees			39.186739 °	39.186038 °
				-122.909436 °	-122.909948 °
DWR ID	DWR_NA0009_02_s _ 2013_9				
Action/Comments					
Thin trees to allow visibility of the ground and room to flood fight.

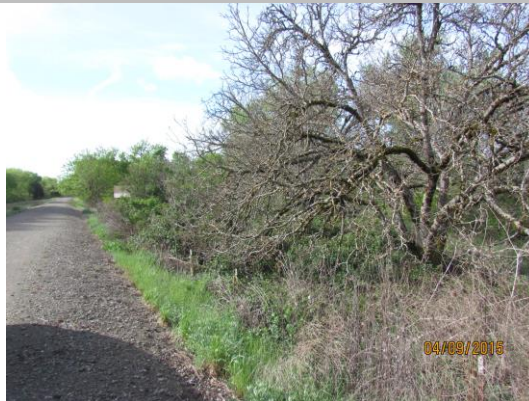
Photo 1 of 1 : SP\_2015\_NA0009\_4\_7\_20150420\_00115.jpg

Remove the vegetation from the landside toe.

LM Start	0.97	Rating **	M	Issue No.	7
LM End	0.98	Issue Type +	Ma	Location *	LS
Category	Earthen Levee			GPS Latitude/Longitude	
				Start	End
Item	Vegetation			39.177218 °	39.176992 °
				-122.913673 °	-122.913642 °
DWR ID	DWR_NA0009_02_s_2012_7				
Action/Comments					
Remove the wild growth other than native grasses from the levee slopes.					
Inspector Comments: Remove the vegetation from the landside toe.

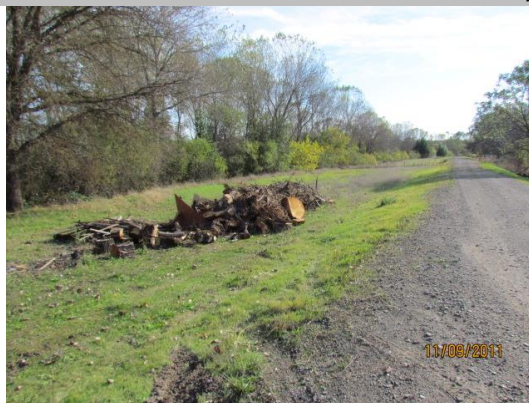
Photo 1 of 1 : SP\_2015\_NA0009\_4\_3\_20150310\_00003.jpg

LM Start	0.99	Rating **	M	Issue No.	3
LM End	0.99	Issue Type +	Ma	Location *	WS
Category	Earthen Levee			GPS Latitude/Longitude	
				Start	End
Item	Encroachments			39.176835 °	39.176835 °
				-122.913558 °	-122.913558 °
DWR ID	DWR_NA0009_02_s_2012_3				
Action/Comments					
Tree or limb

View of the tree prunings on the W/S toe.

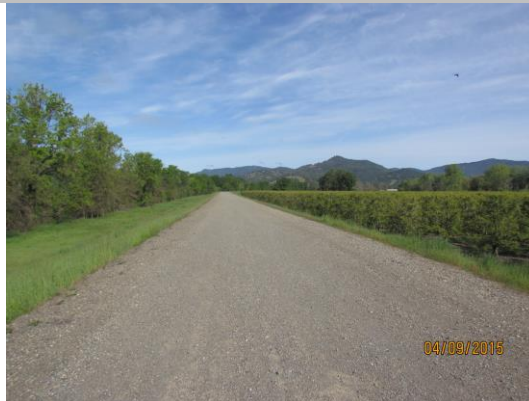
Photo 1 of 1 : SP\_2015\_NA0009\_5\_258\_20150420\_00085.jpg

View of the levee with vegetation on both slopes.

LM Start	0.07	Rating **	A	Issue No.	258
LM End	0.07	Issue Type +	Ma	Location *	LS
Category	Earthen Levee			GPS Latitude/Longitude	
				Start	End
Item	Vegetation			39.148892 °	39.148892 °
				-122.914557 °	-122.914557 °
DWR ID	DWR_NA0009_03_s _ 2015_258				
Action/Comments					
Control annual grass and weeds on the levee slopes and easements.

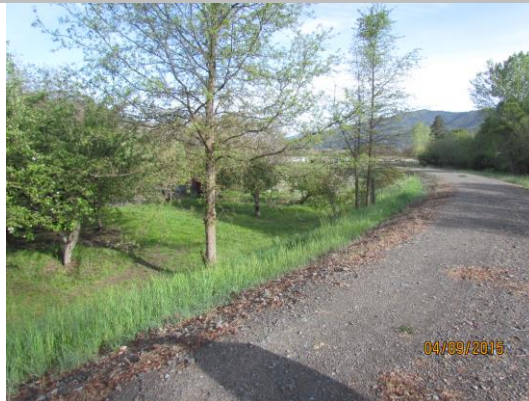
Photo 1 of 1 : SP\_2015\_NA0009\_6\_2\_20150420\_00066.jpg

Trim the trees for better visibility.

LM Start	1.05	Rating **	M	Issue No.	2
LM End	1.18	Issue Type +	Ma	Location *	LS
Category	Earthen Levee			GPS Latitude/Longitude	
				Start	End
Item	Trim / Thin Trees			39.180479 °	39.181947 °
				-122.896567 °	-122.895112 °
DWR ID	DWR_NA0009_04_s_2012_2				
Action/Comments					
Trim trees to at least five feet above ground level.

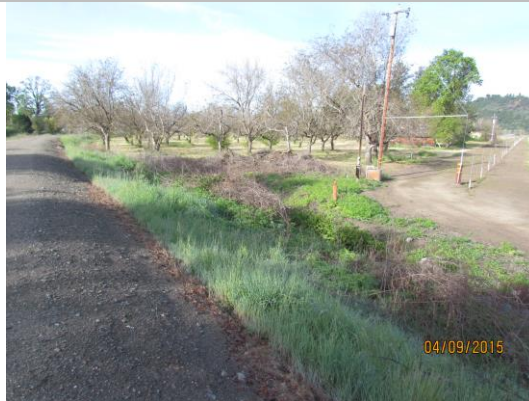
Photo 1 of 1 : SP\_2015\_NA0009\_6\_9\_20150420\_00065.jpg

View of the vegetation growing at the toe.

LM Start	1.19	Rating **	M	Issue No.	9
LM End	1.26	Issue Type +	Ma	Location *	LS
Category	Earthen Levee			GPS Latitude/Longitude	
				Start	End
Item	Vegetation			39.182154 °	39.182951 °
				-122.895005 °	-122.894409 °
DWR ID	DWR_NA0009_04_s_2012_9				
Action/Comments					
Remove the wild growth other than native grasses from the levee slopes.

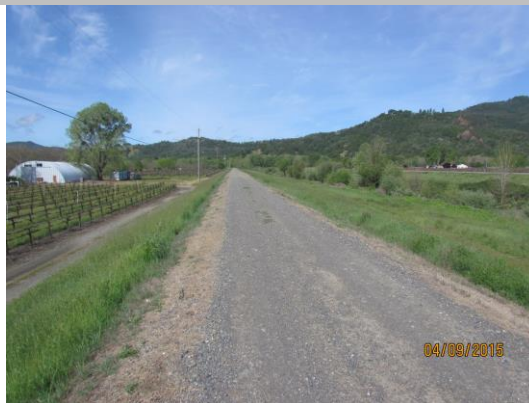
Photo 1 of 1 : SP\_2015\_NA0009\_7\_121\_20150420\_00033.jpg

View of the levee with vegetation on both slopes.

LM Start	0.69	Rating **	A	Issue No.	121
LM End	0.69	Issue Type +	Ma	Location *	LS
Category	Earthen Levee			GPS Latitude/Longitude	
				Start	End
Item	Vegetation			39.175698 °	39.175698 °
				-122.905553 °	-122.905553 °
DWR ID	DWR_NA0009_05_s_2015_121				
Action/Comments					
Control annual grass and weeds on the levee slopes and easements.
